Truck-Tractor Double Trailer
Median Crossover Collision With Motorcoach
and Postcrash Fire on Interstate 5
Orland, California
April 10, 2014

NTSB/HAR-15/01
PB2015-104149

Highway Accident Report

The National Transportation Safety Board (NTSB) determines that the probable cause of the Orland, California, crash was the inability of the FedEx Freight truck driver to maintain control of the vehicle due to his unresponsiveness for reasons that could not be established from available information. Contributing to the severity of some motorcoach occupant injuries were high impact forces; the release of combustible fluids, leading to a fast-spreading postcrash fire; difficulties in motorcoach egress; and lack of restraint use.

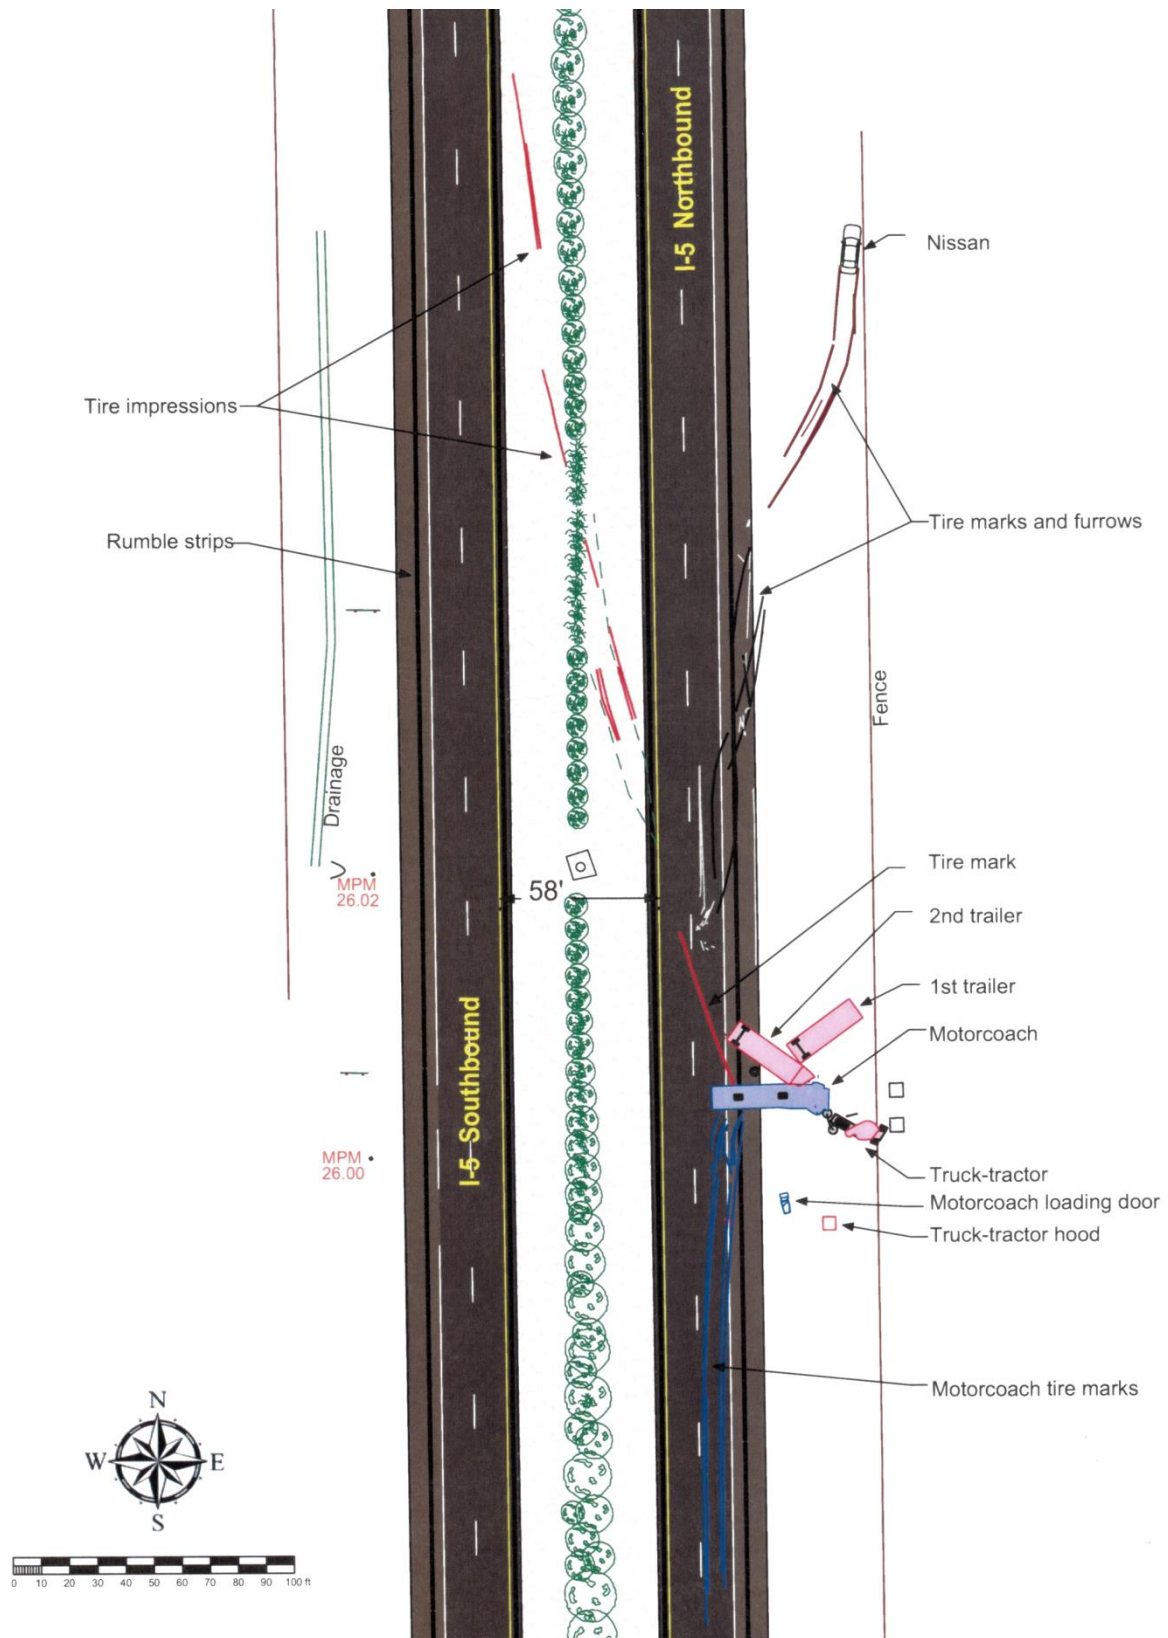
² The truck-tractor traveled about 415 feet from the southbound left pavement edge before impact with the motorcoach. The front of the motorcoach, the truck-tractor, and the first trailer came to rest on the east grassy embankment. The second trailer and half of the motorcoach remained on the shoulder and paved roadway.

Figure 2. Crash scene diagram.

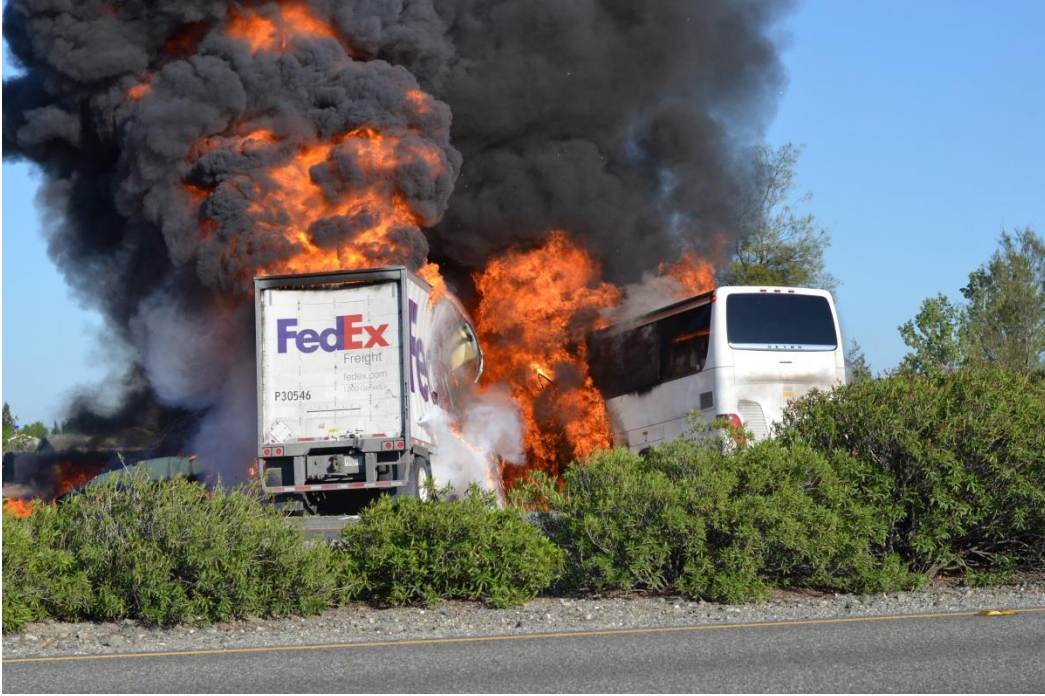
Figure 3. FedEx Freight truck-tractor double trailers and Silverado motorcoach postcrash.
(Source: J. Lockett)

1.4.1.2 Truck Vehicle Systems. The collision impact and postcrash fire destroyed much of the truck. The only major remaining components were the frame, drive train, and trailer axles. The internal surface of the truck-tractor's hood was recovered in an area away from the postcrash fire. It revealed no evidence or indication of a precrash fire, such as soot or smoke damage.⁹

Both the left and right fuel tank mounting systems were damaged in the collision, and some components were missing postcrash. The left fuel tank was melted. The right fuel tank was displaced from the vehicle, and the right side frame rail was displaced inward at the location of the fuel tank. The right steel braided fuel line was intact but ruptured, and the left steel braided fuel line remained connected to the fuel filter. Based on fuel records and average consumption estimated by FedEx Freight, the fuel on board the truck-tractor at the time of the crash was approximately 160 gallons.

The first trailer was hauling a stump grinding machine, which was ejected at impact. The second trailer was empty. The fire destroyed both trailers. Collision damage and the postcrash fire prevented investigators from obtaining individual axle weights for the combination vehicle. CHP used certified portable scales to weigh an exemplar vehicle with approximately the same loading as the truck-tractor and estimated the total vehicle weight to be 41,000 pounds.

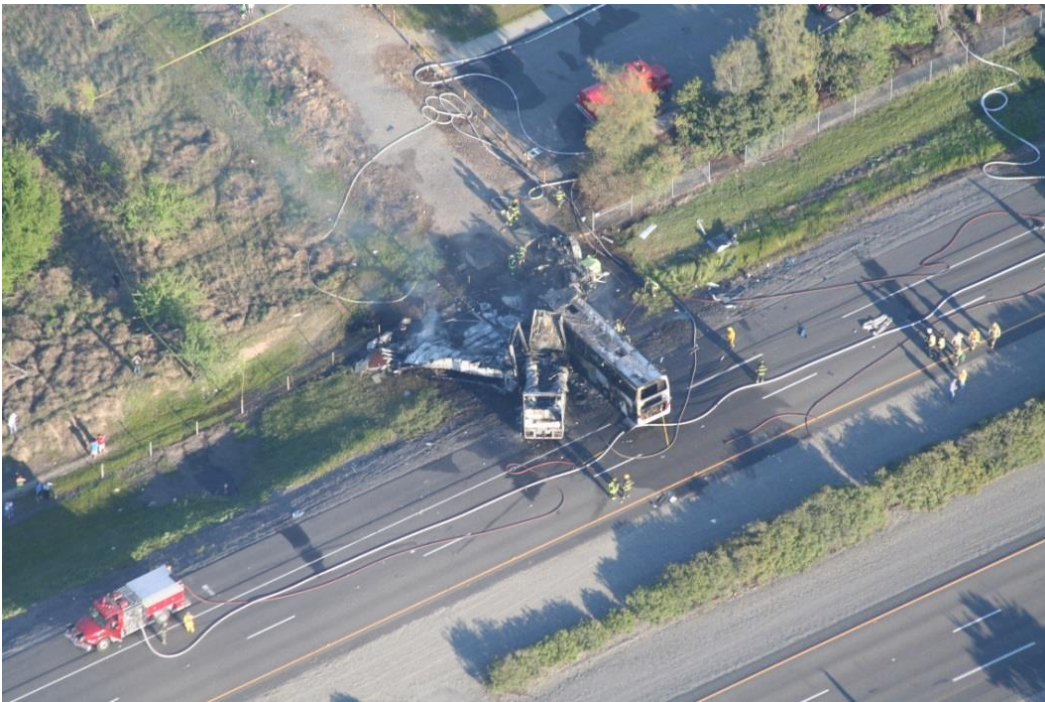
Figure 4. Aerial view of crash scene and center median after fire was extinguished.
(Source: California Highway Patrol)

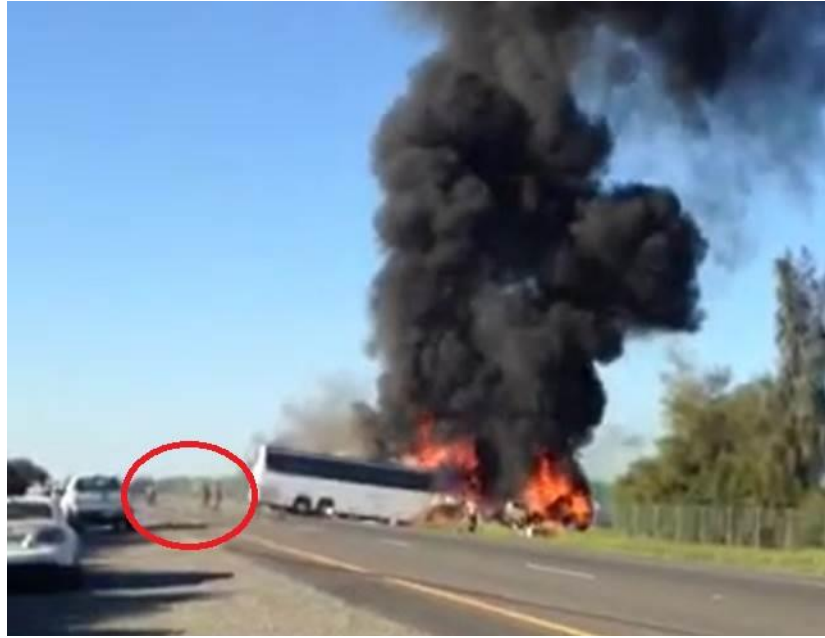
The collision and postcrash fire destroyed windows at rows 1–10 on the driver side and rows 1–4 on the passenger side, and partially destroyed window glazing and window frames behind these rows. Several exit window latch mechanisms and frames near the bus rear—in addition to the wheelchair lift door frame—were intact, though distorted by the heat. The motorcoach was equipped with several onboard video monitors that were damaged as a result of the collision and fire.

The driver and passenger side modesty panel frames were damaged. The driver side first seat row was partially displaced from the seat tracks and deformed backward. The first row of seats on the passenger side was completely displaced and found just aft of the loading stair. Deformations of the remaining passenger seat frames and anchorages were noted on some seats; however, the fire consumed all of the combustible materials in this forward portion of the

Figure 8. Motorcoach postcrash, with occupants (marked with red circle) evacuating toward center median. (Source: witness cellphone video)

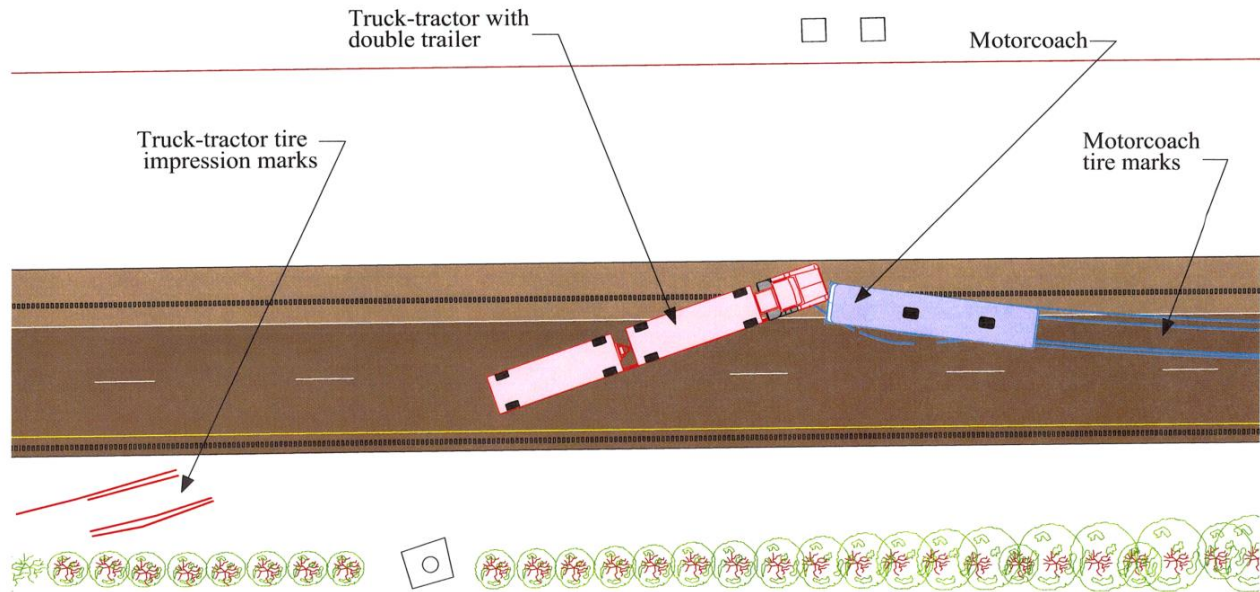
The truck-tractor initially struck the front of the motorcoach, at a relative angle of approximately 156 degrees; maximum deformation was 2 feet 10 inches to the right front corner.²¹ (See figure 12, which appears in section 2.2 of this report.) The front end of the motorcoach sustained the most deformation from the impact and thermal exposure due to the postcrash fire. Interior impact damage was concentrated in the driver compartment area, front loading door, and stairwell, as well as the frame structure, the windshield, and the first two rows (driver and passenger side) of passenger seats. The forward portion of the luggage shelf was crushed; portions of the shelf were intact from row 11 to the rear on the driver side and from row 12 to the rear on the passenger side.

⁶⁴ With an initial speed of 59–57 mph and departing the right southbound travel lane at an angle similar to that of its off-pavement path of travel, the truck-tractor likely struck the motorcoach in about 6.3–6.6 seconds.

⁶⁵ Postcrash scene photographs and damage to the two trailers (primarily the first trailer) indicate that they also made contact with the motorcoach during the collision, which influenced the vehicles' post-impact travel to point of rest.

Figure 12. Crash scene diagram depicting truck-tractor tire impressions in median, motorcoach pre-impact tire marks, and vehicle angles at impact.
